## BULGING PATTERNS OF COKE DRUMS

**Mahmod Samman, Ph.D., P.E.**  
Houston Engineering Solutions, LLC  
Houston, TX, USA  
+1(832)512-0109  
[mms@hes.us.com](mailto:mms@hes.us.com)

### ABSTRACT

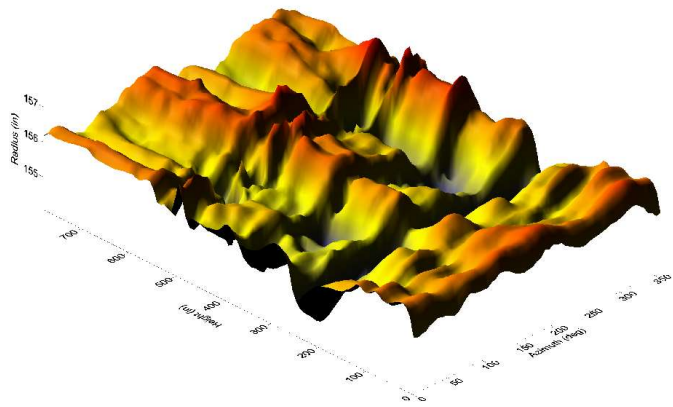
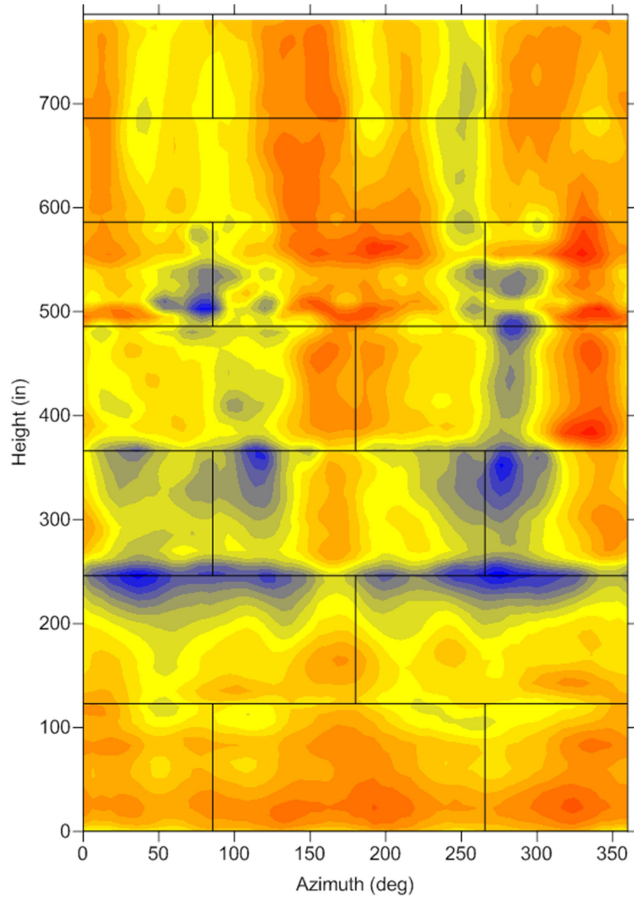
act as restraining belts on the expanding shell. Less frequently, however, the opposite happens and welds grow relative to plates. An example is shown in the Chrome alloy drum of Figure 1 where growth is noticeable on both sides of the third, fourth, and fifth seams counting from bottom to top. In the 3D map, these bulges look like circumferential depressions at the seams.

**Figure 1: Three and two-dimensional maps of a coke drum with Seam Bulging**

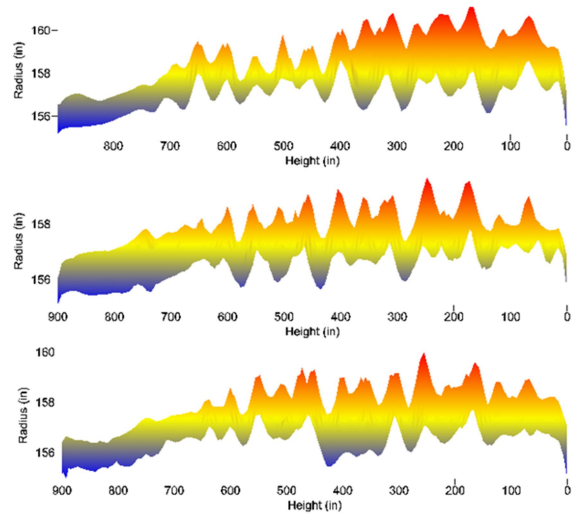
2. **Bottom Growth:** The average radius of the bottom courses of the shell is mostly uniform and larger than the top. The transition between large and small occurs over a relatively short distance above the outage level (i.e. height of maximum fill). Examples of this type of bulging are the Chrome alloy drums shown in Figure 2.

**Figure 2: Bottom Growth**

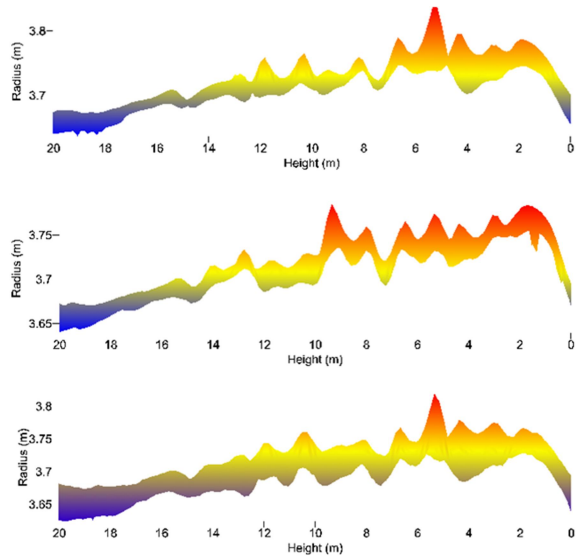
3. **Tapered Growth:** As with Bottom Growth, the average radius of the bottom of the drum is larger than the top but the transition occurs over most of the drum length. We mainly found this type of bulging in Carbon steel drums such as the ones in Figure 3.

**Figure 3: Tapered Growth**

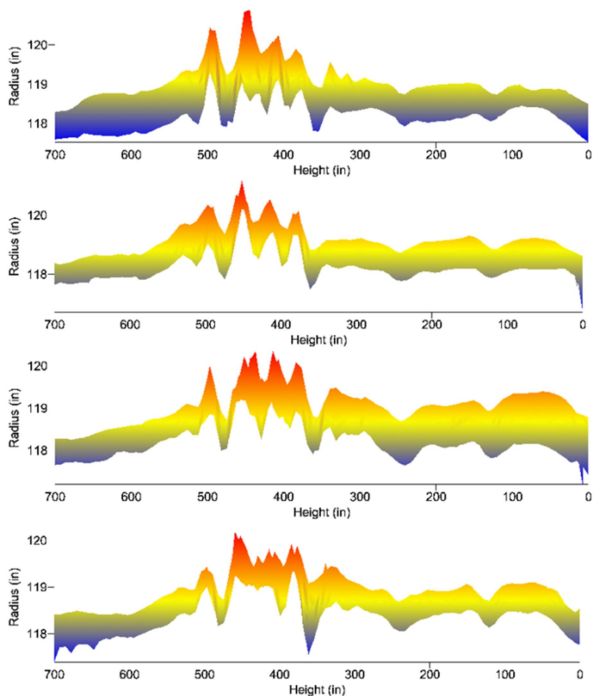
4. **Outage Growth:** A radius increase at the outage level that is typically located between half and two thirds of shell height. Examples are the Carbon Steel drums shown in Figure 4.

**Figure 4: Outage Growth**

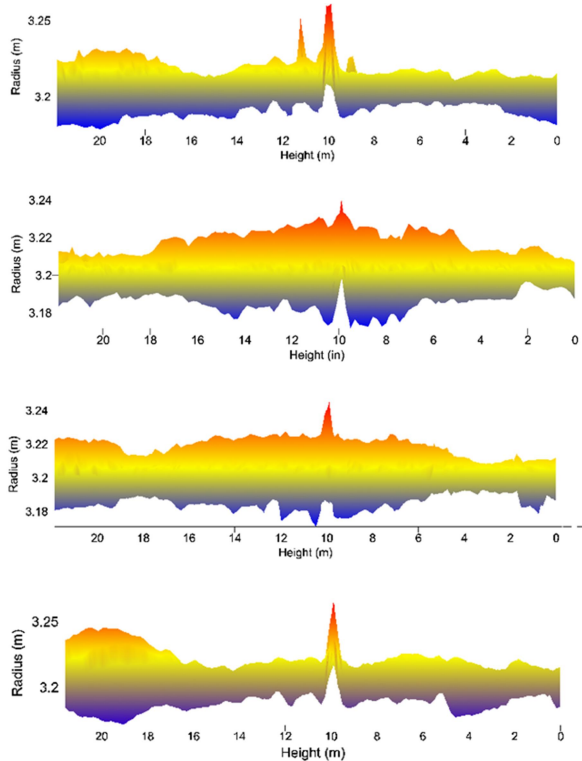
5. **Mid-height Growth:** A radius increase at the middle of shell height. Examples are the Chrome alloy drums shown in Figure 5.
6. **Band Bulging:** This very common type appears as bands of outward and/ or inward axisymmetric bulging that extend most of or all the way around the circumference and is not centered at a seam weld. An example of a drum that developed both inward and outward band bulges is the Chrome alloy drum shown in Figure 6.

induced distortions. The same process is used in field-fabricated drums which are also known to develop Mid-height Growth bulges before they are placed in service.

**Figure 5: Mid-height Growth**

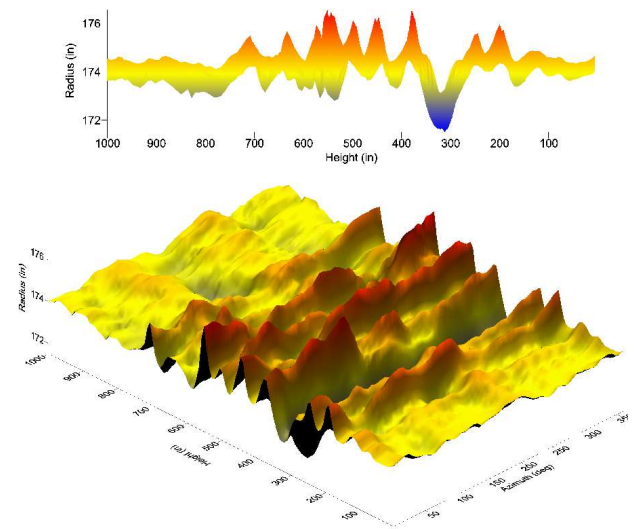
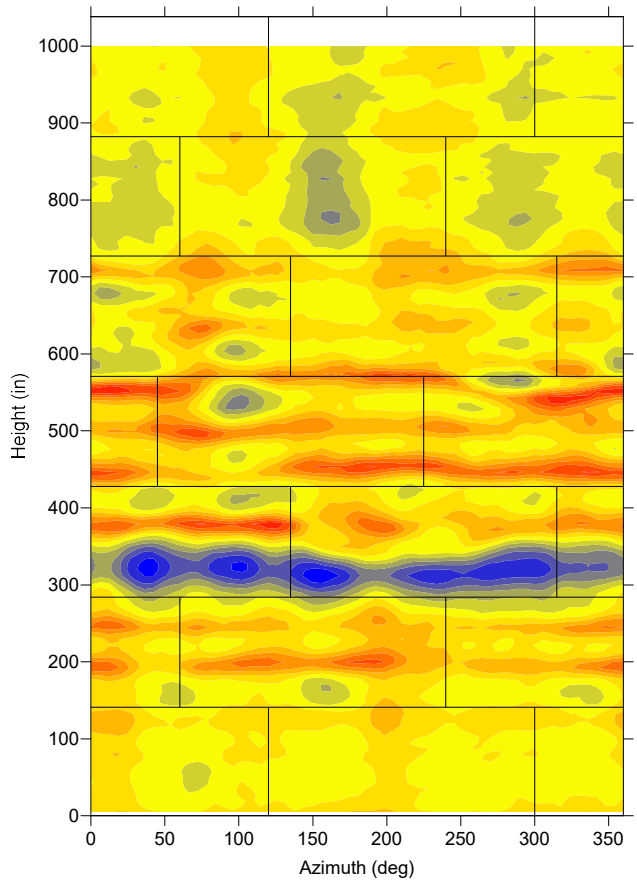
We currently don't fully understand all the loading mechanism(s) that cause uniform Band Bulging. It may be caused by an operating practice that results in hotter or cooler thermal conditions at particular elevations, such as abrupt changes in quench water flow rate. Alternatively, these bulges may be caused by local bulges that, with time, grow around the circumference of the drum.

**Figure 6: Band Bulging**

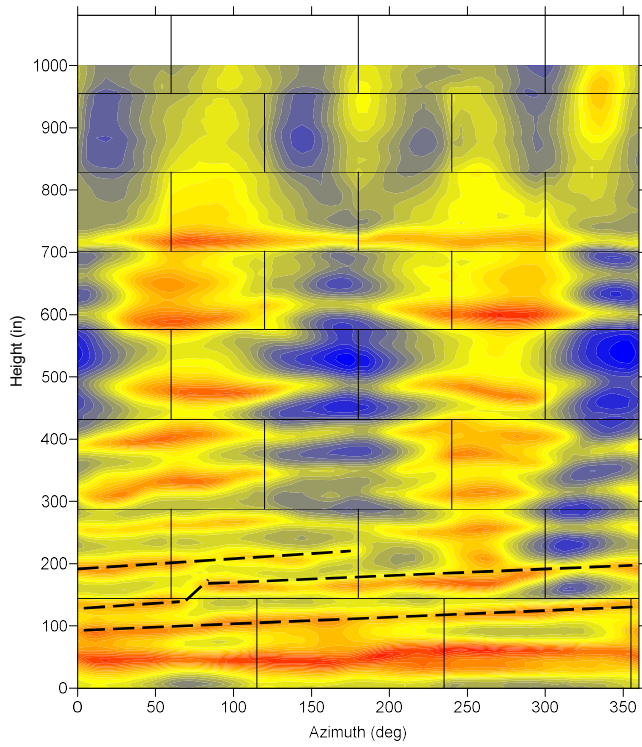
7. **Helical Bulging:** This is a special case of Band Bulging in which the band is not perfectly axisymmetric. Instead, elevation changes along the axis of the drum to form a helix, such as the one at the bottom two courses of the Chrome alloy drums of Figure 7.

d. Uneven quenching: The injection of cold water into a bed of solid coke often results in non-uniform cooling of the drum. Temperature differences in excess of 400°F are not uncommon across the diameter. Such large side-to-side thermal gradients can cause drum tilting, also known as the “banana effect”, as well as Band Bulging on the compression side of drums. Helical Bulging may also be caused by uneven quenching from spiraling water channels.

**Figure 7: Helical bulging (indicated by dotted lines)**

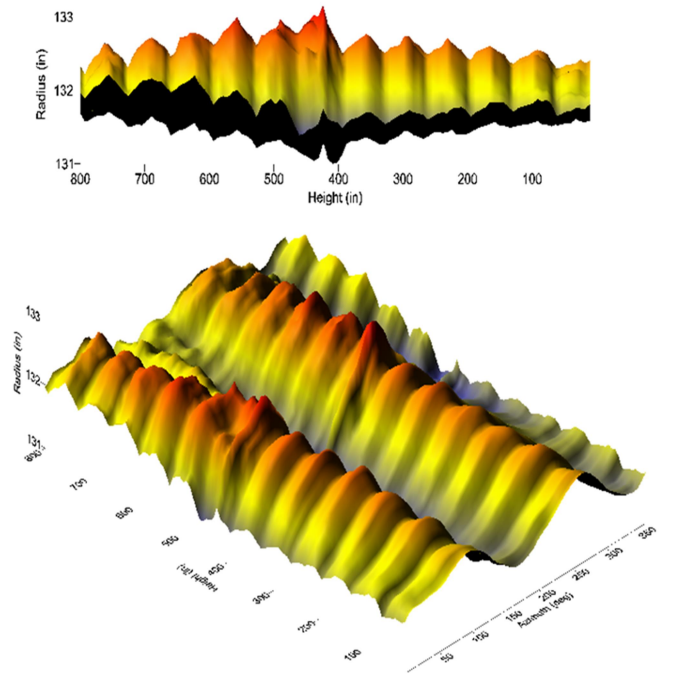
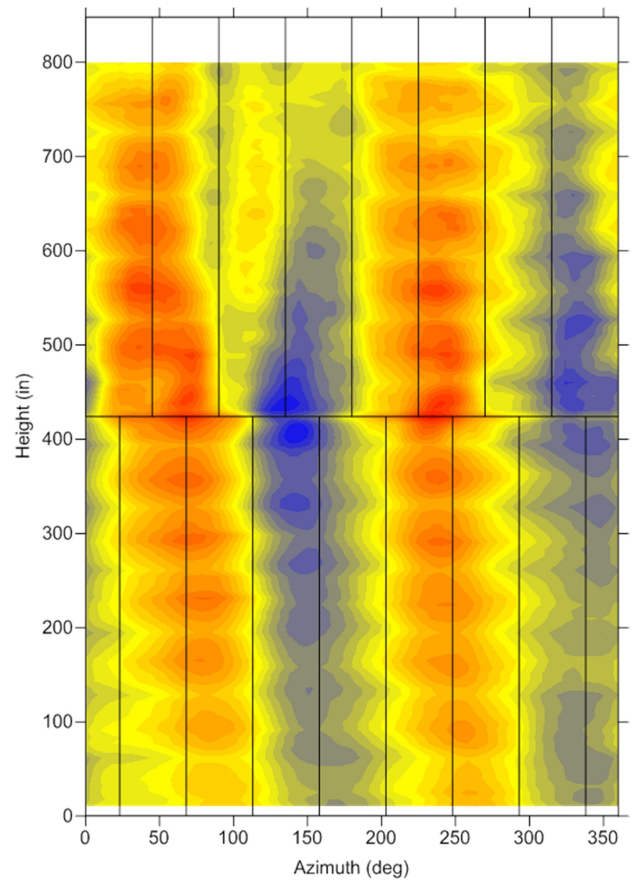
8. **Accordion Bulging:** A zigzag variation of shell radius over the entire shell that does not correlate with circumferential seam weld locations. An example is the brand new Chrome alloy vertical-plate drum of Figure 8 that shows significant zigzag bulging and out-of-roundness (ovality).

Since Accordion Bulging is found in new drums, we know that it is caused by the fabrication process but it is not clear exactly what part of the process causes these unusually consistent zigzag bulges that cover the entire length of drums.

**Figure 8: Accordion bulging**
